To: AST Customers
Re: Possible Antenna Issues

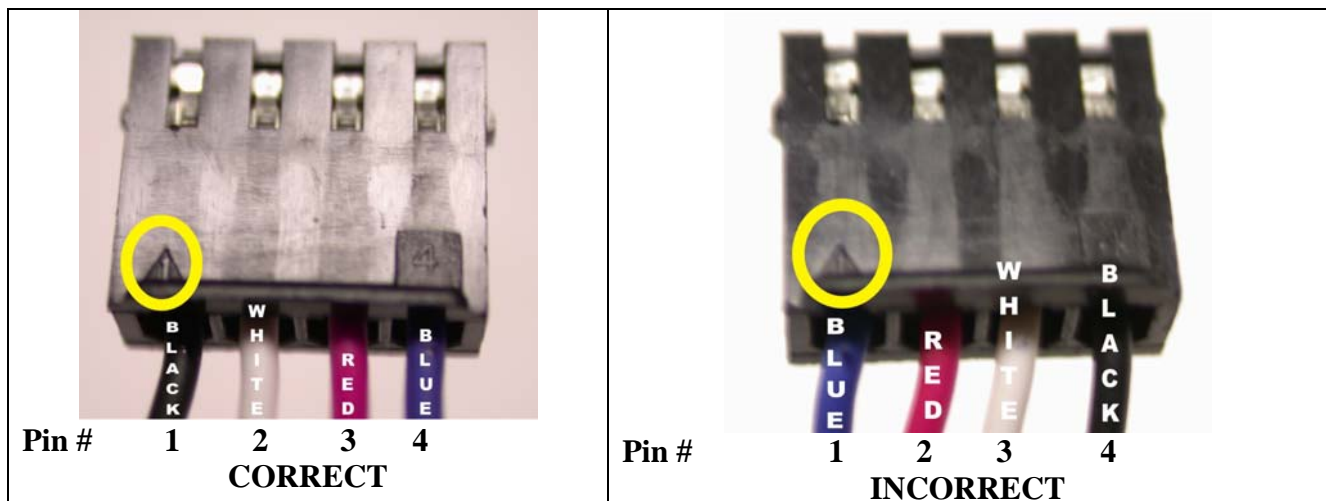
It has come to our attention that a small portion of antenna cables may have been shipped with the incorrect pin configuration. In most cases the system will not respond and the LEDs on the antenna will stay on continuously. We are currently doing our best to check all cables before shipping. If you are experiencing this problem check the pictures below for the correct pin configuration.
