To: AST Customers  
Re: DL-3 Door Lock Module

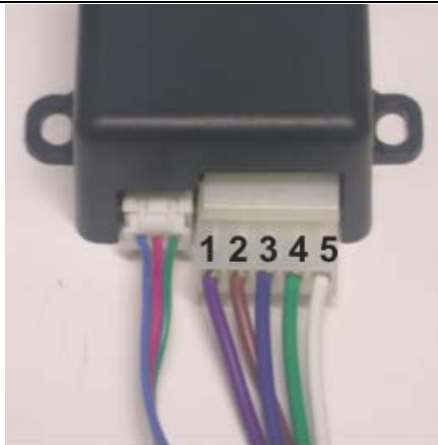
**Correct Pin Configuration**  
Pin #1 Purple  
Pin #2 Brown  
Pin #3 Blue  
Pin #4 Green  
Pin #5 White

It has come to our attention that a small portion of the DL-3 door lock modules may have been shipped with the incorrect pin configuration. This model will not function with this incorrect configuration. If you are experiencing this problem check the pictures below for the correct pin configuration. We are currently doing our best to check all the harnesses for this product and apologize in advance for any inconvenience.

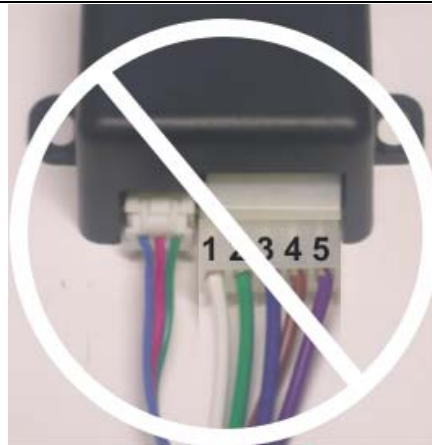
**Incorrect Pin Configuration**  
*Pin #1 White*  
*Pin #2 Green*  
*Pin #3 Blue*  
*Pin #4 Brown*  
*Pin #5 Purple*
